WELCOME TO THE FIRST KSDA NEWSLETTER

SOLUTION FOR THE KENTON SAND DUNE

THE GROWTH OF THE SAND DUNE AT THE BUSHMAN RIVER END

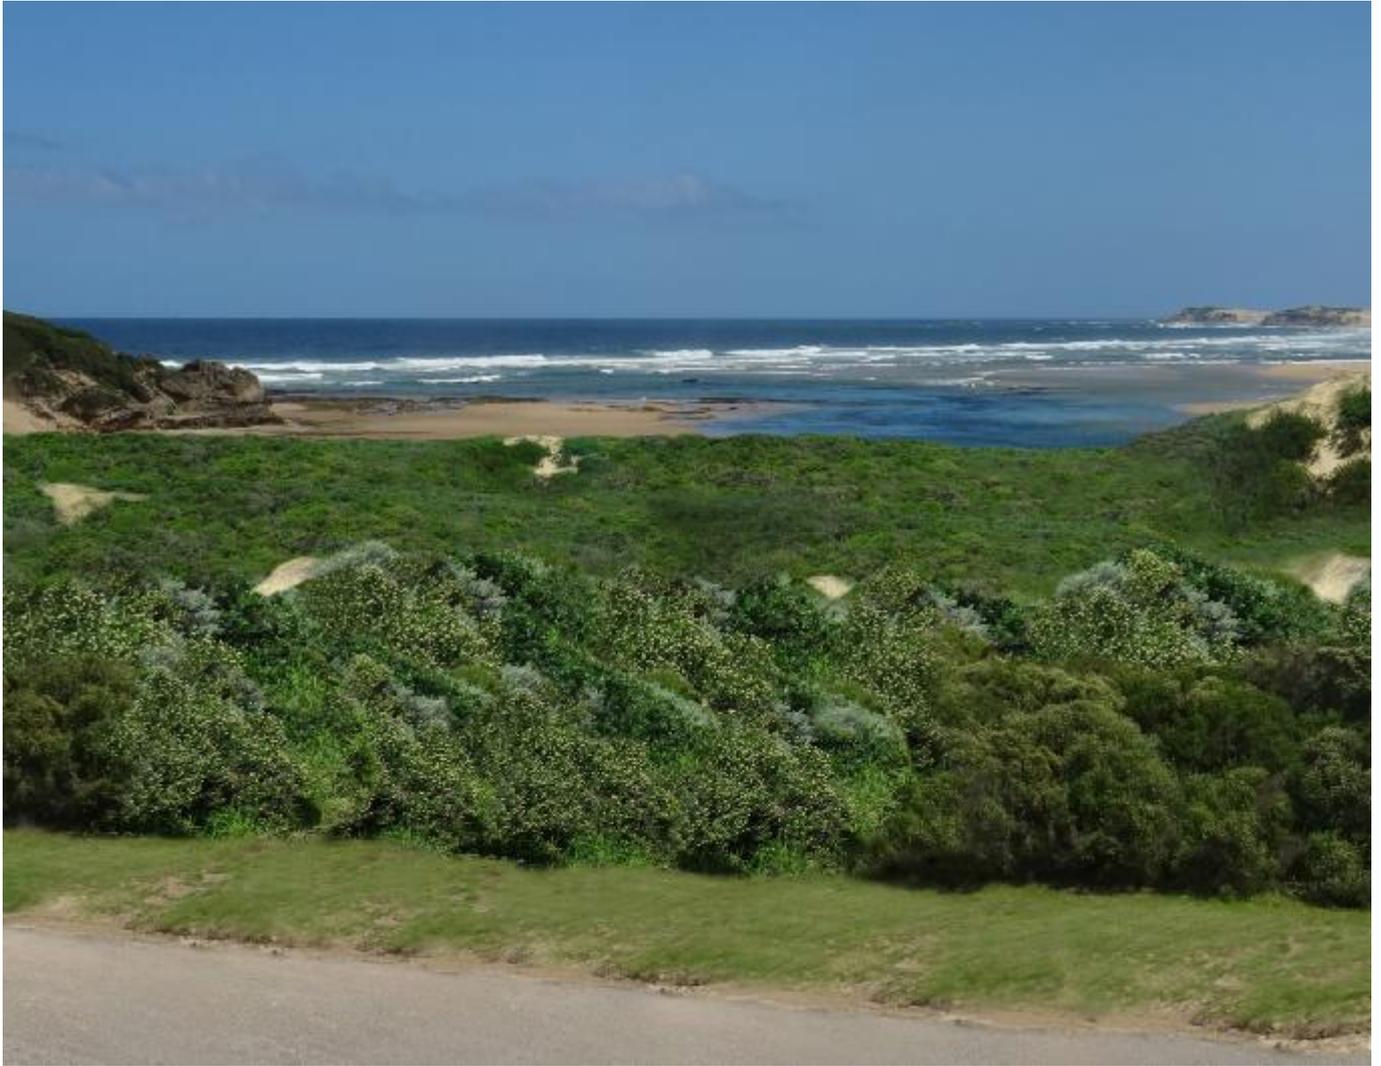
AN IMPRESSION OF THE NEW VEGETATED AND STABILISED SAND DUNE

This impression shows the outcome of the project which will permanently restore the natural beauty of this unique part of our wonderful coast. It removes the risk to property and enables everyone to continue their enjoyment of walking through Dry Bones Valley to Middle Beach and to enjoy unspoilt views of the Estuary.
